AFRL-RX-TY-TR-2008-4572

ADVANCED SPALL REPAIR METHODS AND EQUIPMENT

**Michael I. Hammons
Air Force Research Laboratory**

FEBRUARY 2009

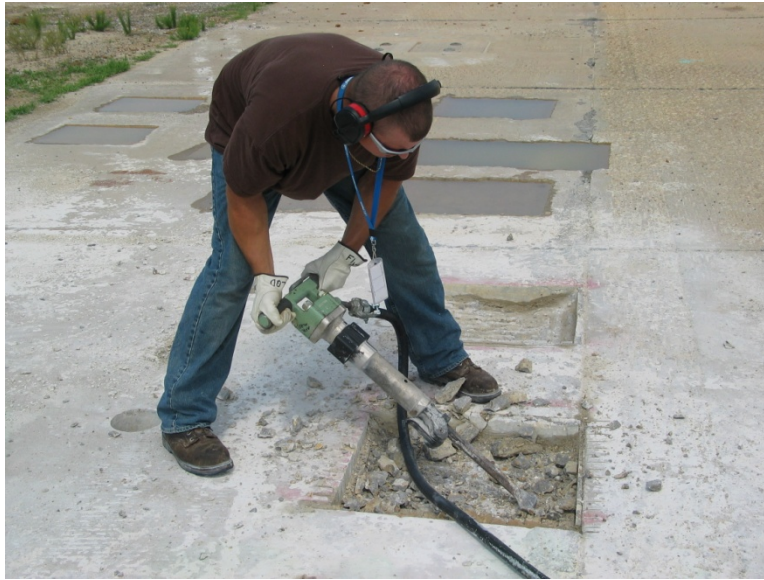
Figure 1. 30-lb Jackhammer Used to Prepare Spalls.

The common method to remove material from a spall repair is to use a portable pneumatic jackhammer as shown in Figure 1. ACI RAP Bulletin 7 recommends that jackhammers larger than 30 lbs not be used, because they may cause damage

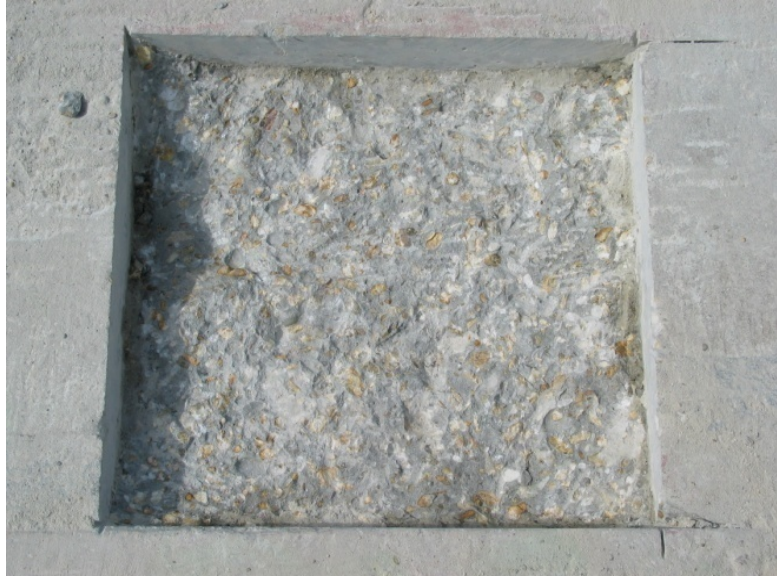
Figure 2. Photo of Completed Excavation using 30-lb Jackhammer.

to the surrounding concrete (4). For this experiment a 2 ft by 2 ft area was cut using a walk-behind saw to a depth of approximately 4 inches. The concrete inside the cut was removed with a 30-lb pneumatic jackhammer. A nail-point breaker tip was used to break up the concrete, and a spade tip was used to dress the repair area. Final clean up was performed by shoveling the rubble in to a loader bucket, sweeping around the hole, and vacuuming the fines from the hole. Figure 2 shows a photograph of a completed spall excavation prepared with the jackhammer.

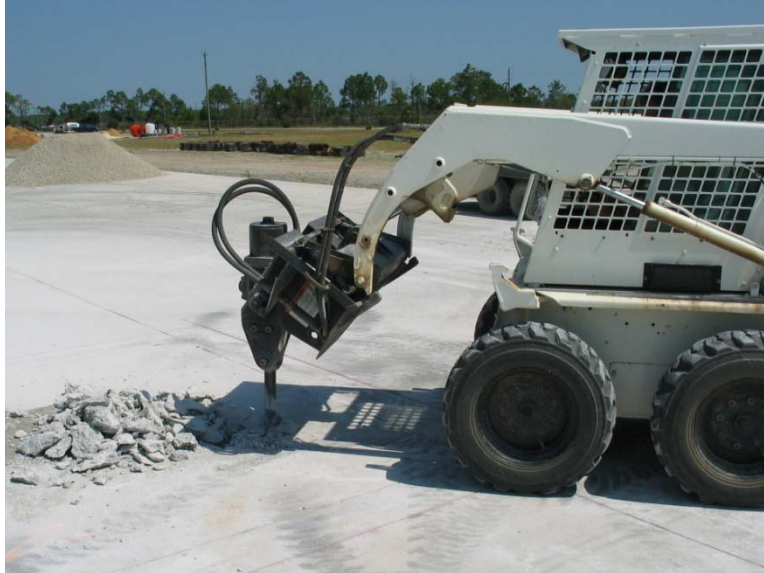
Figure 3. Hydraulic Breaker on Wheeled Skid Steer Loader.

The spall was prepared using a hydraulic percussion breaker fitted to a wheeled skid steer loader as shown in Figure 3. The breaker is powered by the auxiliary hydraulic system on the loader. The breaker had an operating weight of 736 lbs and produced 1310 blows per minute at a hydraulic flow rate of 17.2 gallons per minute yielding approximately 300 ft-lbs of impact energy. The diameter of the nail-type breaker probe was 2.56 inches.

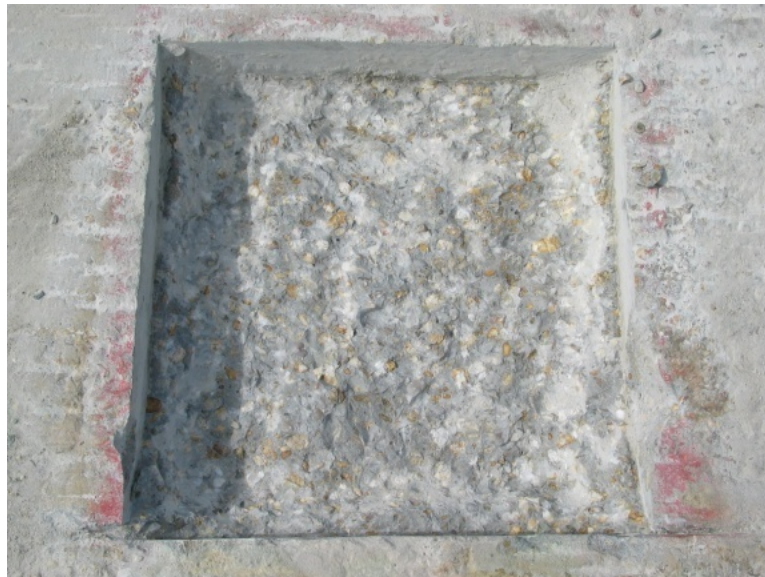
Figure 4. Hole Excavated using Hydraulic Breaker.

Figure 4 contains a photograph of a completed spall excavation made with the hydraulic breaker.

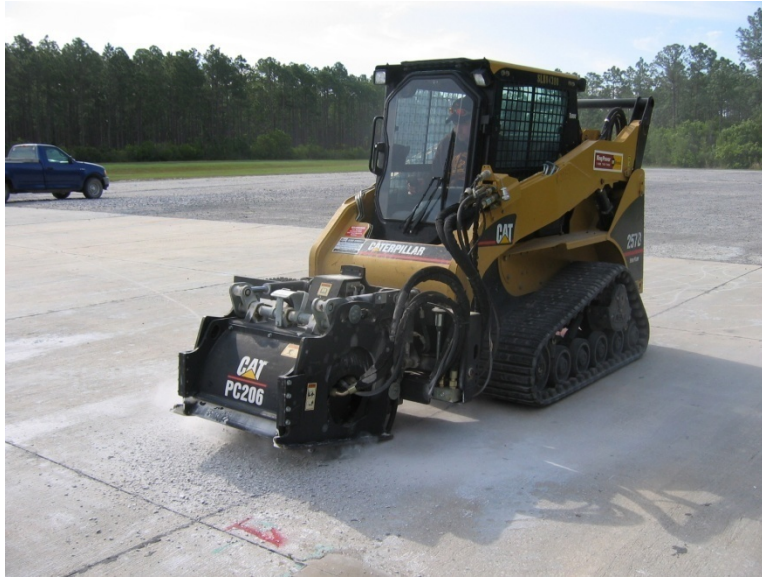
Figure 5. Cold Planer on Skid Steer Loader.

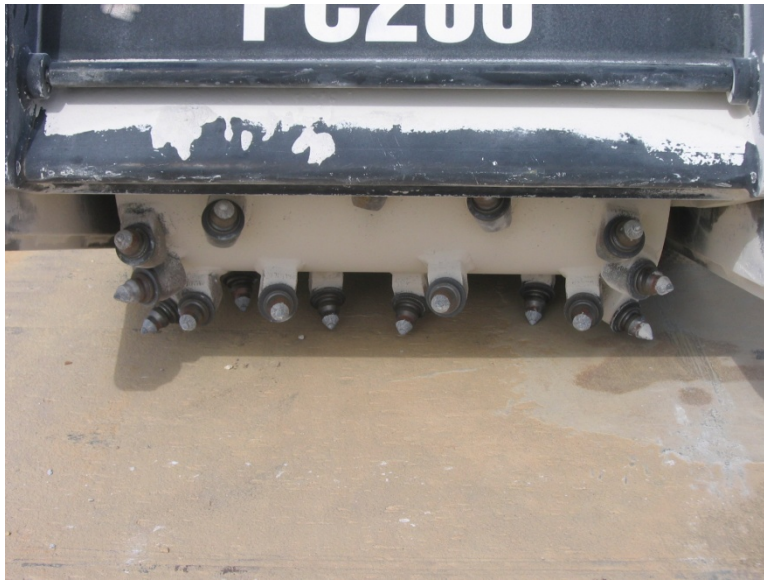
Figure 6. Cold Planer Drum.

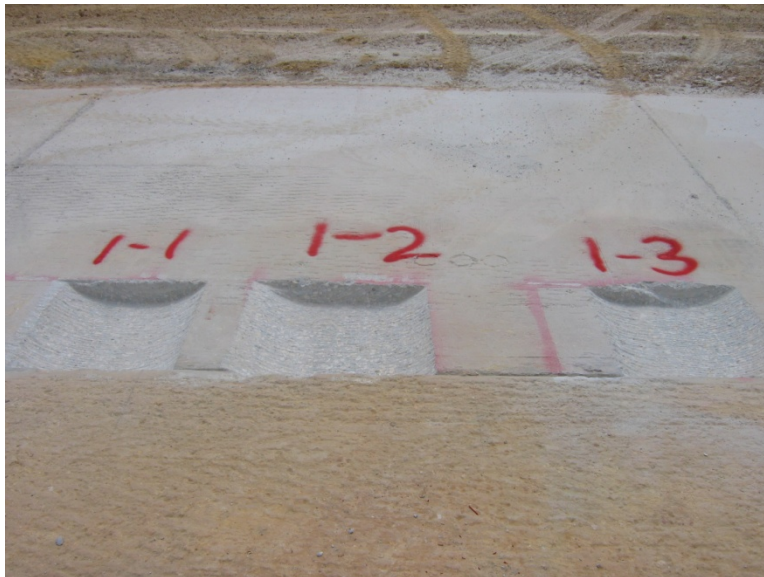
Figure 7. Excavations Prepared with Cold Planer.

Figure 7 shows a photograph of the completed excavations. Note that the cold planer drum leaves a radius in the excavation such that the bottom surface of the spall excavation is not parallel with the surface of the pavement.

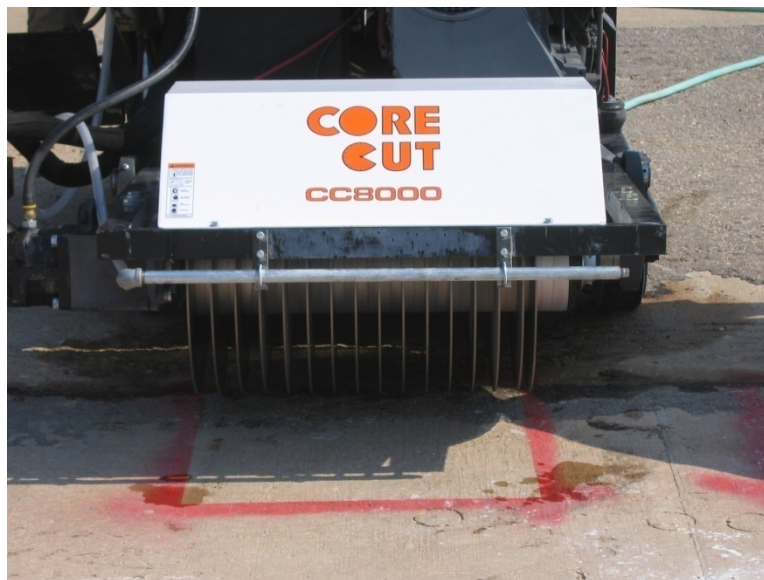
Figure 8. Multiple Blade Saw.

diamond-tipped saw blades. The blade shaft was hydraulically driven by a Diamond Products CC8000 rider saw powered by a 78-hp diesel engine. The distance between the saw blades was variable, and two center-to-center spacings were employed ($\frac{3}{4}$ inch and $1\frac{1}{2}$ inches) for this research.

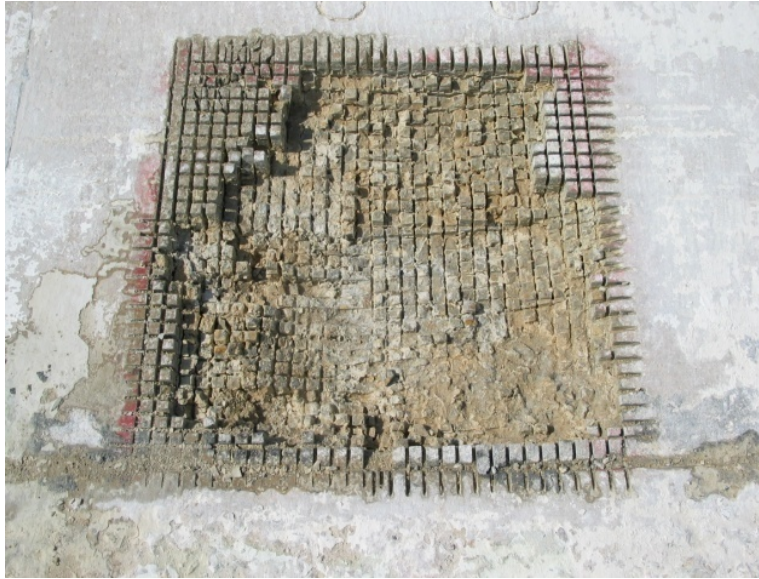
Figure 9. Saw-cut Excavation (3/4-inch Spacing) Prior to Removal of Debris.

The saw was employed twice at right angles to produce an orthogonal grid of saw cuts. Three holes each were prepared with the saw blades spaced at $\frac{3}{4}$ inch or $1\frac{1}{2}$ inches. After the cuts were made, the material was removed with a 30-lb pneumatic jackhammer. Figure 9 and Figure 10 show photographs of the saw-cut excavations before and after removal of debris, respectively.

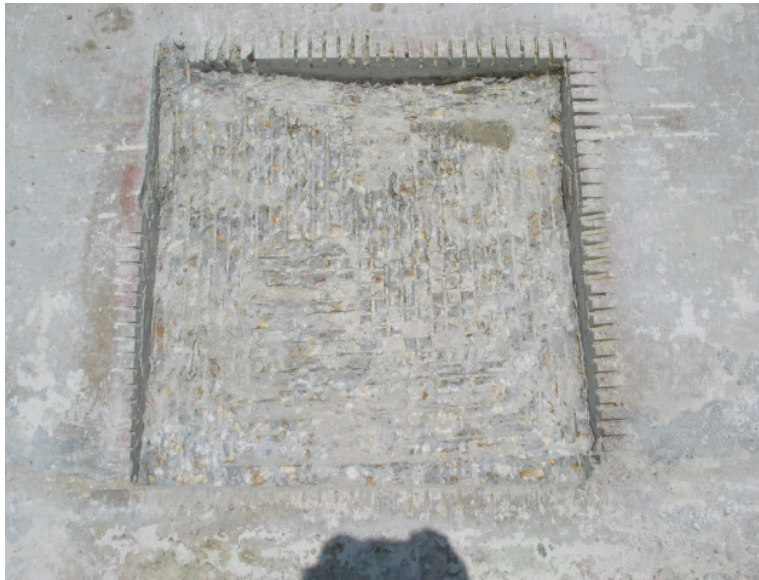
Figure 10. Saw-cut Excavation (3/4-inch Spacing) after Removal of Debris.

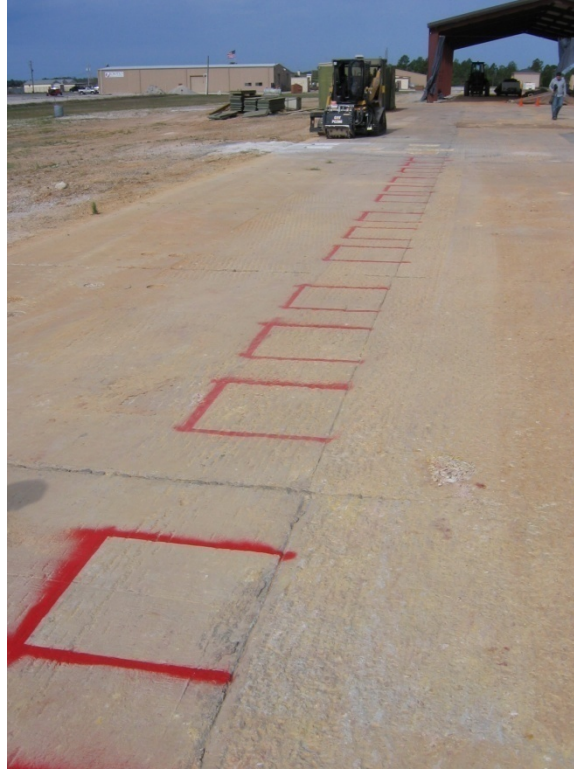
Figure 11. Layout of Spall Locations before Excavation

As previously mentioned, the experiment consisted of trials on five excavation methods. Each excavation method was conducted in triplicate. Figure 11 shows a photograph of the layout of the 15 2-ft by 2-ft spall areas on the pavement prior to excavation. All spalls were required to have one (and only one) side along a joint.

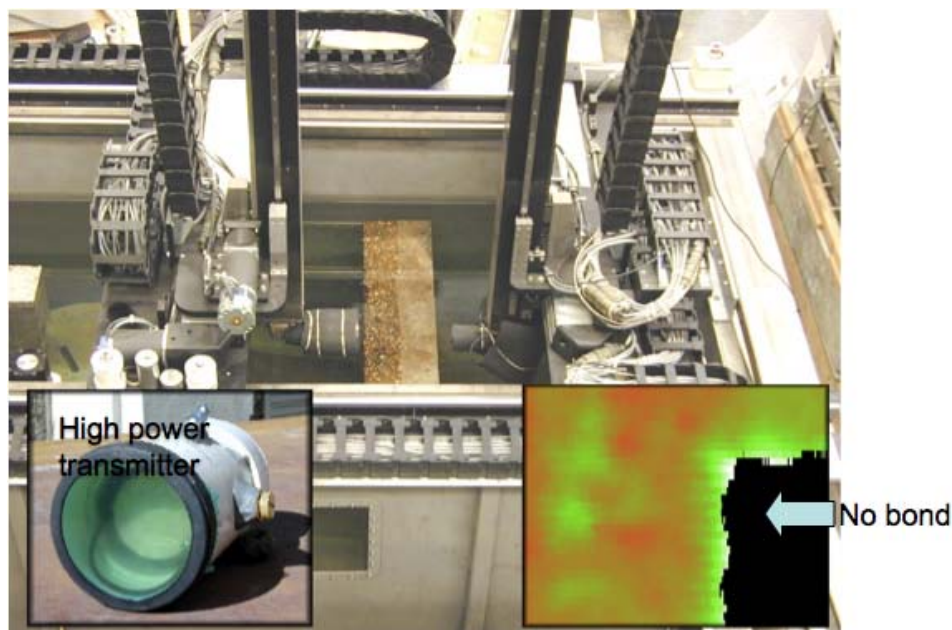
Figure 12. URI System during Through-Transmission Scan.

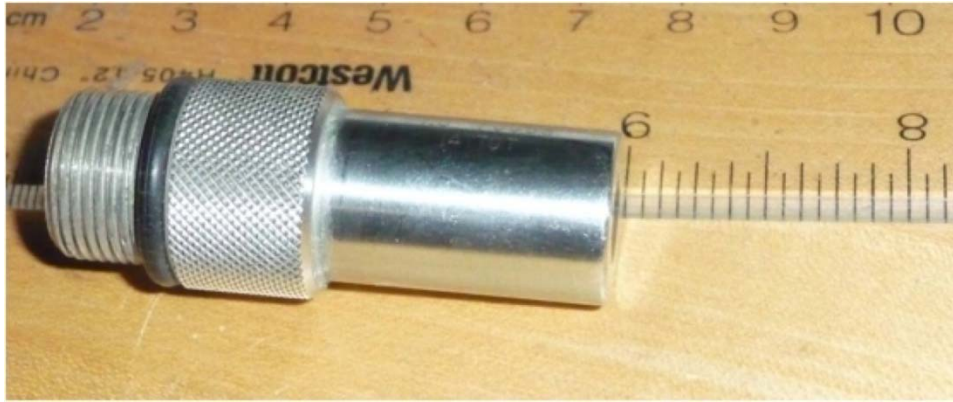
Figure 13. 15 MHz Ultrasonic Transducer with a 1-inch Focal Distance used for Reflection Imaging.

URI is a new technique for imaging concrete that focuses on the mechanical characteristics of the concrete paste and aggregate. It is particularly sensitive to locating damaged or weak aggregates, entrapped and/or entrained air, or failure between various interfaces. URI relies on a laboratory immersion scanning system to collect data from either smooth cored or cut concrete surfaces. The immersion scanning system is shown in Figure 12. Note that in this example a specimen (not from this project) is in the tank, and the tank is partially filled with water. The water serves to carry and focus the stress waves from the transducer to specimen face and back. The transducers used in this echo imaging effort are shown in Figure 13. Though not clear in this view, the front of the transducer is curved slightly to increase the focusing performance.

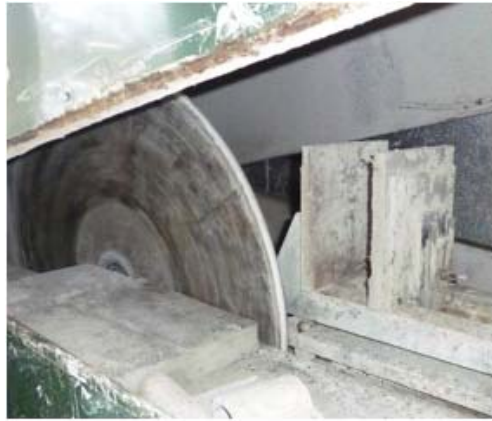
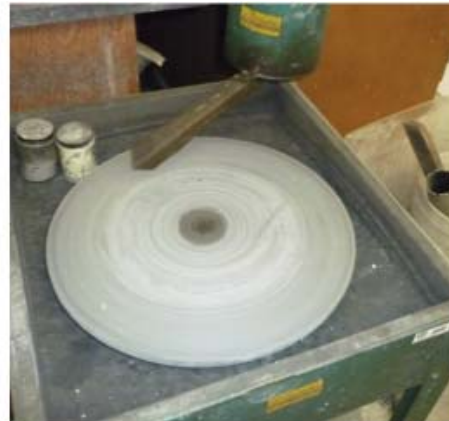
Figure 14. Autofeeding Concrete Saw and Polishing Wheel Used in Specimen Preparation.

Because very smooth surfaces are preferable for higher resolution effort our cores were cut in half and polished. Figure 14 shows the laboratory cutting and polishing equipment used in the processing of these specimens. The polished cores were scanned in two batches. One core was repeated in both scans to provide reference readings and validate comparable system operation.

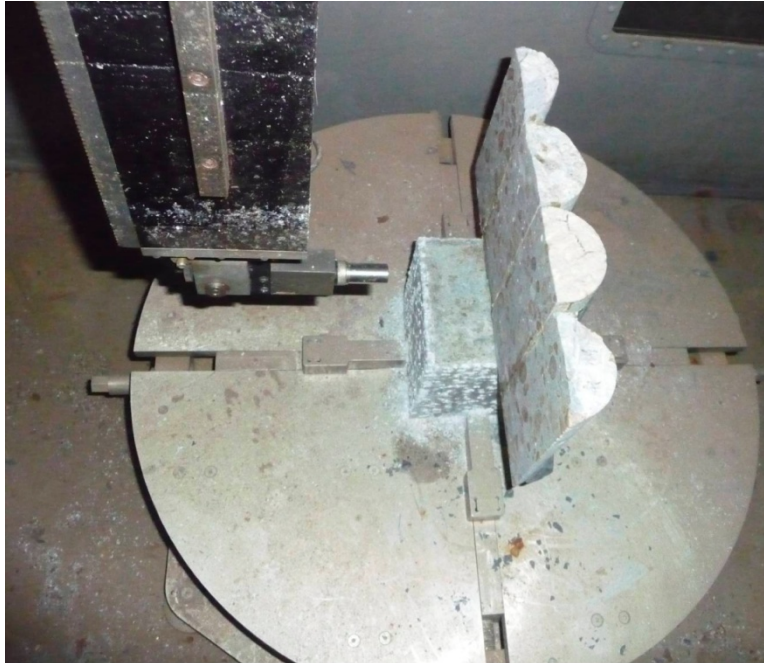
Figure 15. Specimen on Turntable with Scanning Arm and Transmitting / Receiving Transducer (Tank is Dry).

Figure 15 shows a group of cut and polished specimens sitting on the turntable in front of the scanning transducer. The water has been removed from the tank in this photograph. Scanning the specimens in groups help maintain scan to scan consistency in terms of the test setup and speeds up the overall process as alignment is a necessary and tedious part of the process. Either the turntable or vertical tilt is adjusted until the scanning plane of the transducer stays parallel with the face. The distance from transducer to specimen is measured on the personal computer that runs the scanning application as the two-way travel time or time of arrival of the pulse. Iteratively the axial alignments are adjusted until negligible changes in arrival times are observed. The multiple specimens are pre-set to be co-planar by placing them flat on a surface such as a tabletop (polished side down and using sulfur potting compound and/or quick set epoxy to grout the rounded surfaces together.

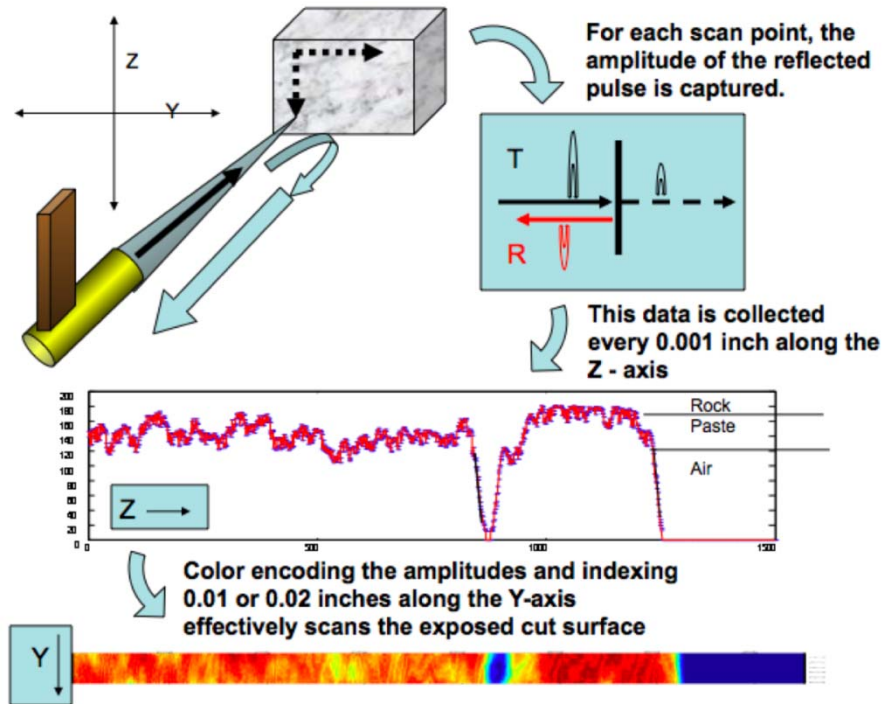
Figure 16. Process to Generate Scan Images from Focused Reflection Scan.

Figure 16 illustrates the measurement and data manipulation used to generate scans. In general the reflected pulse is digitized and the scan axis is indexed. After a line scan is completed the system moves the transducer back to the start location (one-direction scanning was done to minimize effects from system vibration) and collects the next line of data. Once the area has been scanned the amplitude data is color encoded and c-scan images are generated. Figure 17 shows a scan image where weak aggregates and cracks were imaged. Aggregate strength was verified by application of a scratch test.

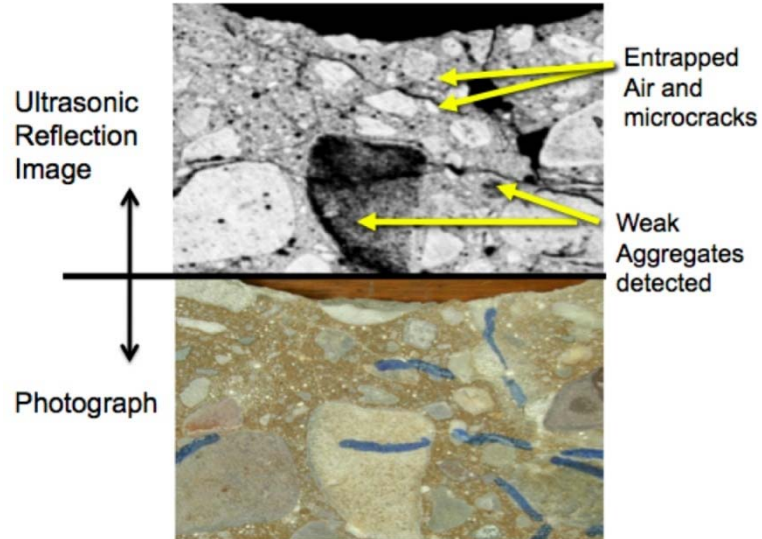
Figure 17. Example Data Showing Detection of Weak aggregate, Cracking, and Air Voids.

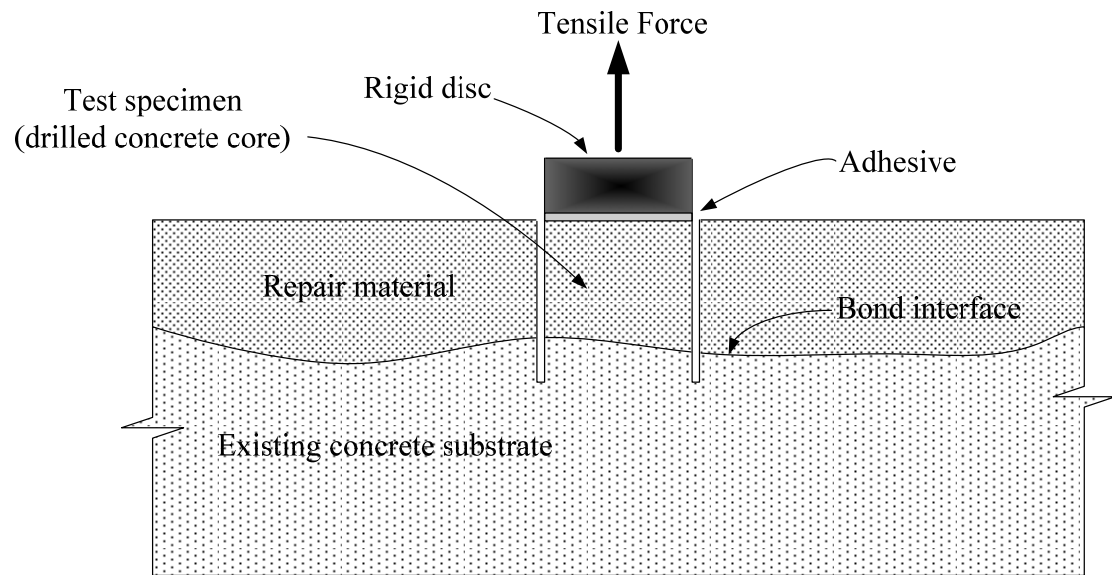
Figure 18. In-Situ Tensile Pull-off Test Preparation.

Figure 18 shows a sketch of the test preparation. A core bit was used to drill through the repair material and into the substrate. A rigid disc was attached to the top of the drilled core using a high-strength adhesive. A testing device (Figure 19) applied a tensile force to the rigid disc at a constant rate until fracture occurred. The tensile force and location of the fracture (at the adhesive, at the bond interface, within the repair material, or within the substrate) were recorded.

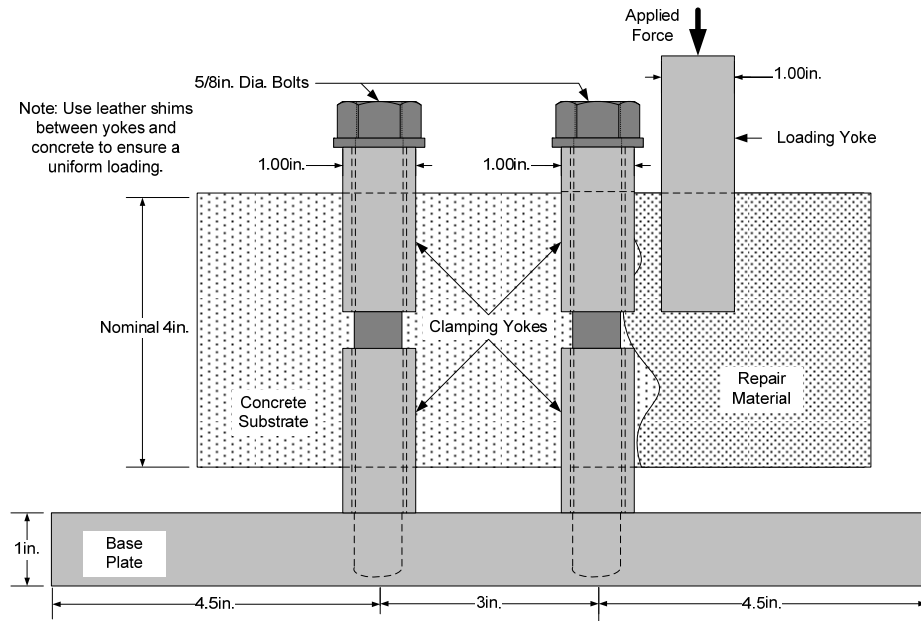
Figure 20. Sketch of Direct Shear Test Device.

An AFRL-developed testing protocol was employed to measure the direct shearing strength of the bond interface on 4-inch diameter cores extracted from the spall repairs. A direct shear test apparatus (as shown in the sketch in Figure 20) was fabricated in the shops at AFRL/RXQ. The apparatus consisted of two clamping yokes designed to secure the core to a base plate. A third yoke (or loading yoke) was positioned near the end of the core to transmit the shearing force to the core. Leather shims were employed to insure uniform contact between the core and the yokes at all contact areas. The apparatus and core were placed in a Forney Model LT-920-D2 universal testing machine capable of a maximum compressive force of 400,000 lbs, and the test was conducted at a loading rate of approximately 500 lbs/min. The load at fracture was recorded, and the shearing force at failure was calculated at the load at fracture divided by the cross-sectional area of the core.

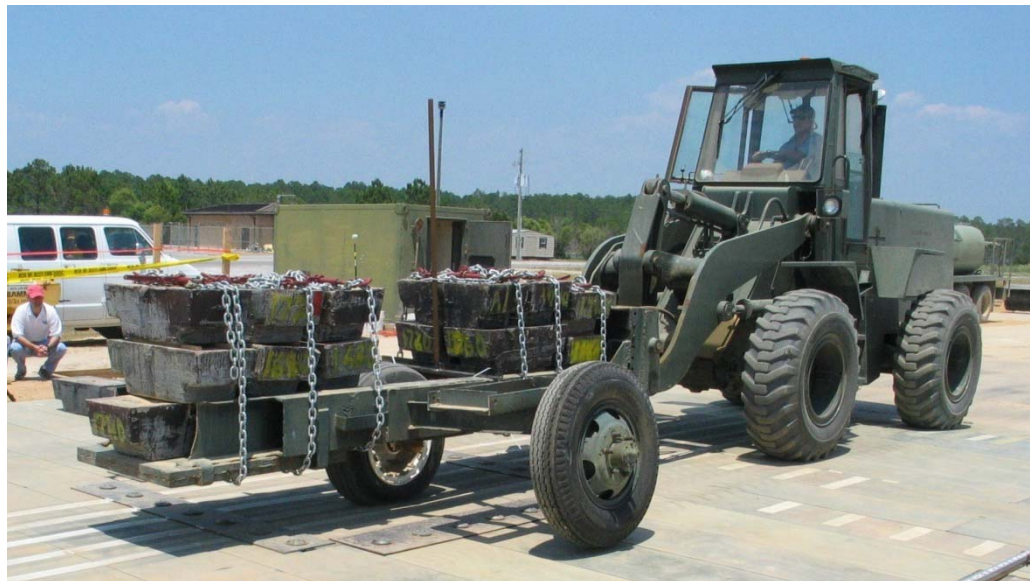
Figure 21. F-15E Load Cart.

The spall repairs were evaluated under 1500 passes of AFRL's F-15E load cart (Figure 21). A single-lane trafficking pattern was used in which all tire loads were applied to the center of the spall repair area. One traverse of the spall field was defined as two passes (one pass up and one pass back). The wheel loading was 35,200 lbs. At 25, 50, 75, 100, and every 100 passes thereafter trafficking was paused, and the spall repairs were inspected and photographed. No active sensors or instrumentation were employed.

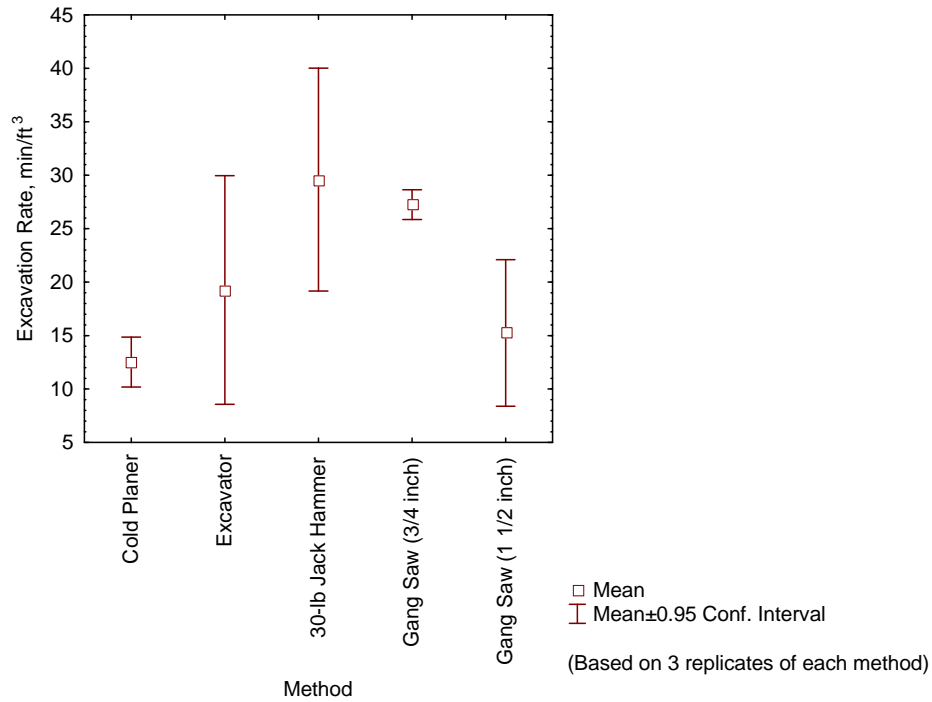
Figure 22. Whisker Plot of Excavation Rate.

A pair wise t-test procedure was used to compare the means to determine if the observed differences in the mean value were statistically significant given the large scatter of the data. The results of these tests are presented in Figure 23. The value tabulated in each cell is the P value that resulted from the pair wise t-test for the combination of treatments represented by the cell. A lower P value indicates a greater significance. In Figure 23, all cells with a P value less than 0.05 are highlighted in orange. This indicates that there is a greater than 95 percent probability that the differences observed between the two methods are statistically significant. Using these analyses, we observe that the production rates for the 30-lb jackhammer are statistically different from those of the cold planer, hydraulic breaker, and the gang saw at $1\frac{1}{2}$ -inch spacing. Comparing with Figure 22, we observe that each of these methods is a significant improvement in production rate over the 30-lb jackhammer.

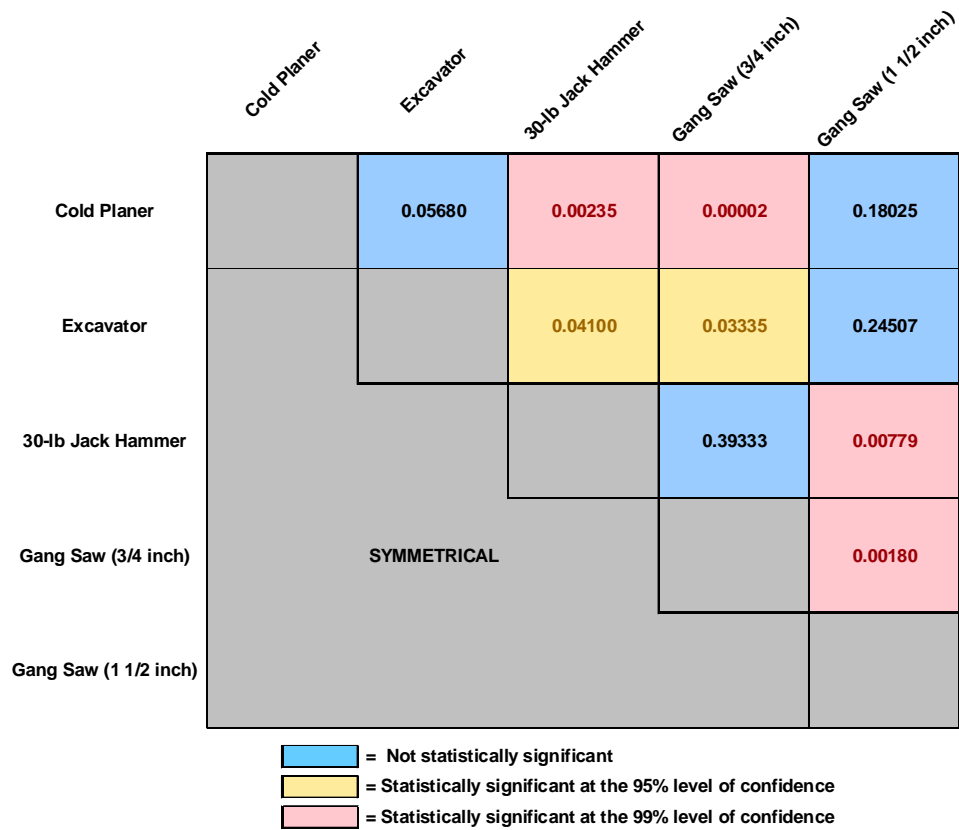
Figure 23. P Value Matrix for Excavation Rate.

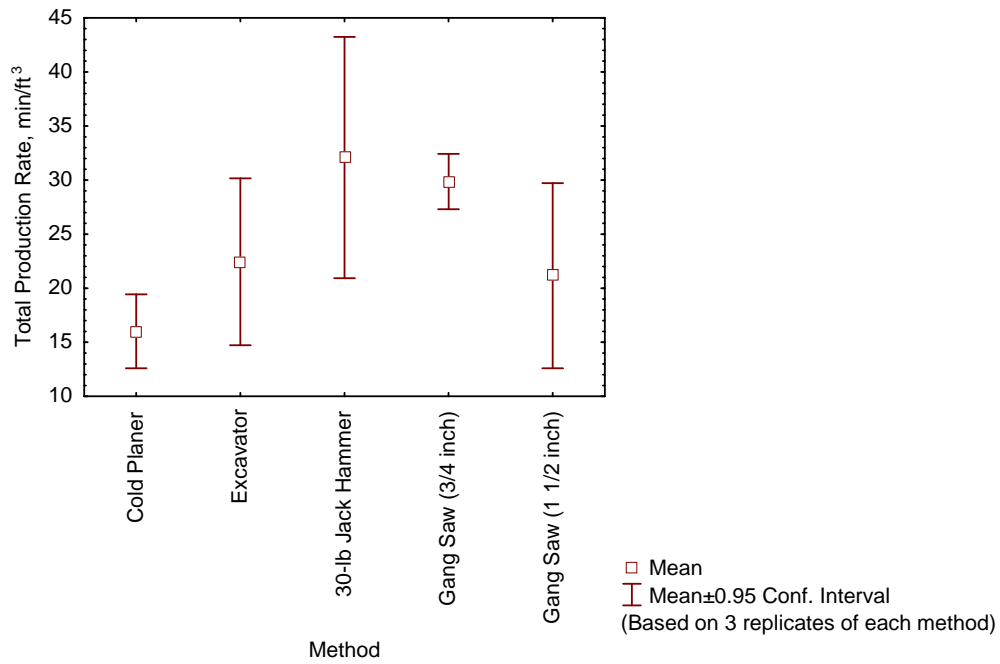
Figure 24. Whisker Plot of Total Production Rate.

Figure 24 and Figure 25. The results were similar to that for excavation rate, except that the difference between the mean values for jackhammer method and the hydraulic breaker were significant in this case.

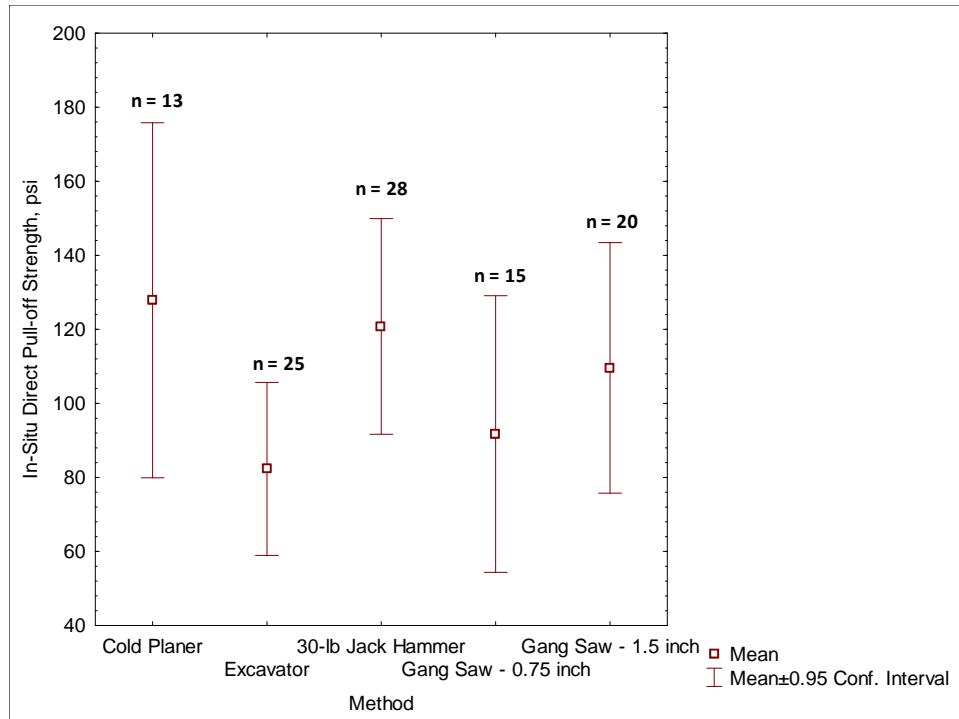
Figure 26. Whisker Plot of Pre-Trafficking In-Situ Pull-Off Data.

The results of the pre-trafficking in-situ pull-off experiments are summarized in the plot shown in Figure 26. The greatest observed mean pull-off strength was for the cold planer, followed, in order, by the jackhammer, gang saw at 1½ inches spacing, gang saw at ¾ inch spacing, and finally the hydraulic breaker. However, the scatter in the data is quite large, and statistical analysis was required to evaluate the significance in the observed means. Pair wise t-tests were conducted on each of the observed treatments, and these results are summarized in Figure 27. The value tabulated in each cell is the P value that resulted from the pair wise t-test for the combination of treatments represented by the cell. A lower P value indicates a greater significance, and cells with a P value less than 0.05 are highlighted in orange. This indicates that there is a greater than 95 percent probability that the differences observed between the two methods are statistically significant. For these experiments, the t-tests indicated that only the differences in the means between the hydraulic breaker and cold planer and hydraulic breaker and jackhammer were statistically significant at the 95 percent confidence level, and one cannot statistically distinguish between the means of the other treatments at the 95 percent confidence level.

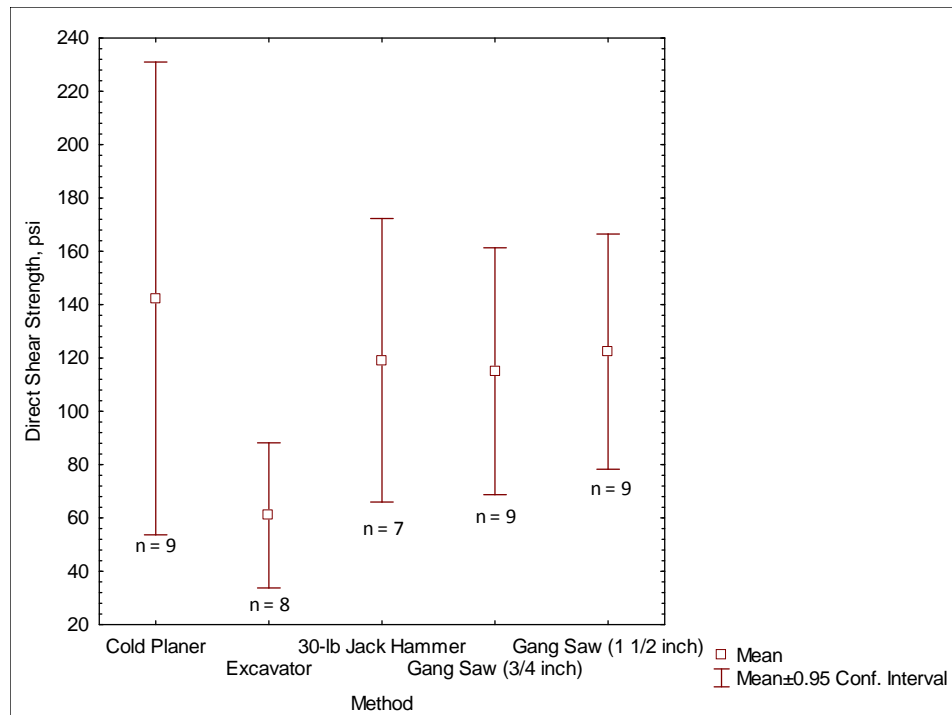
Figure 28. Whisker Plot of Pre-Trafficking Direct Shear Data.

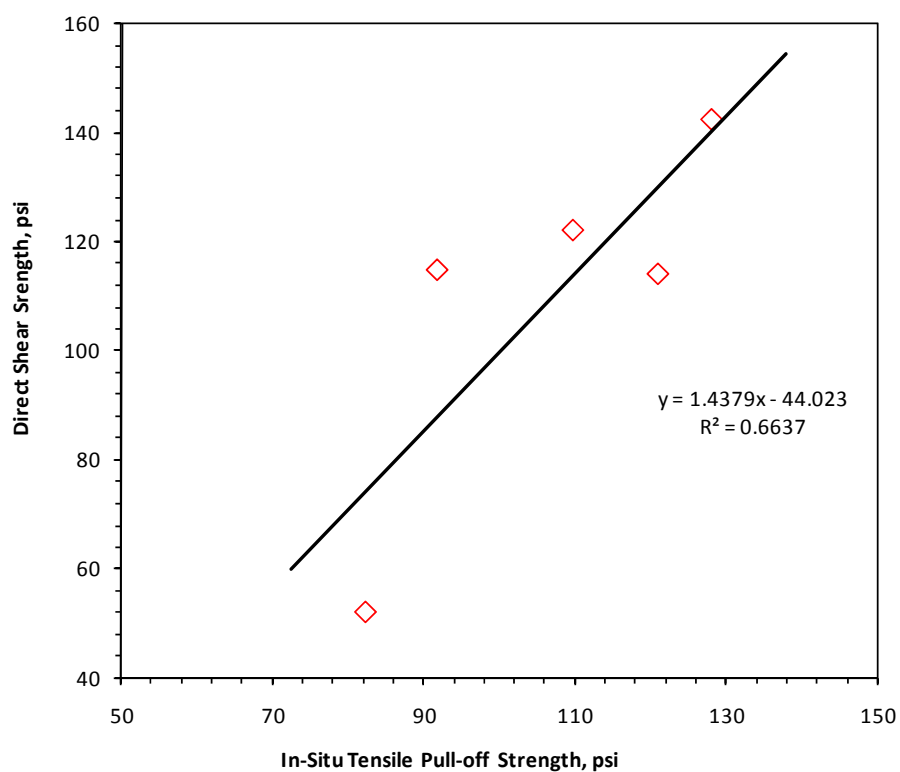
Figure 30. Correlation of Pull-Off Strength and Direct Shear Strength.

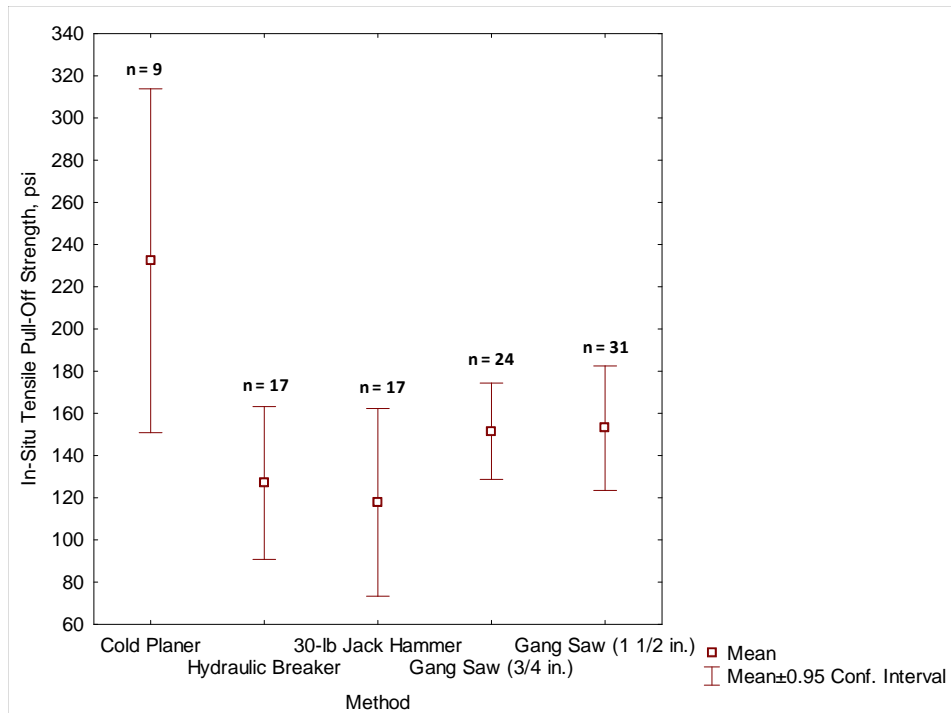
Figure 31. Whisker Plot of Post-Trafficking In-Situ Pull-Off Data.

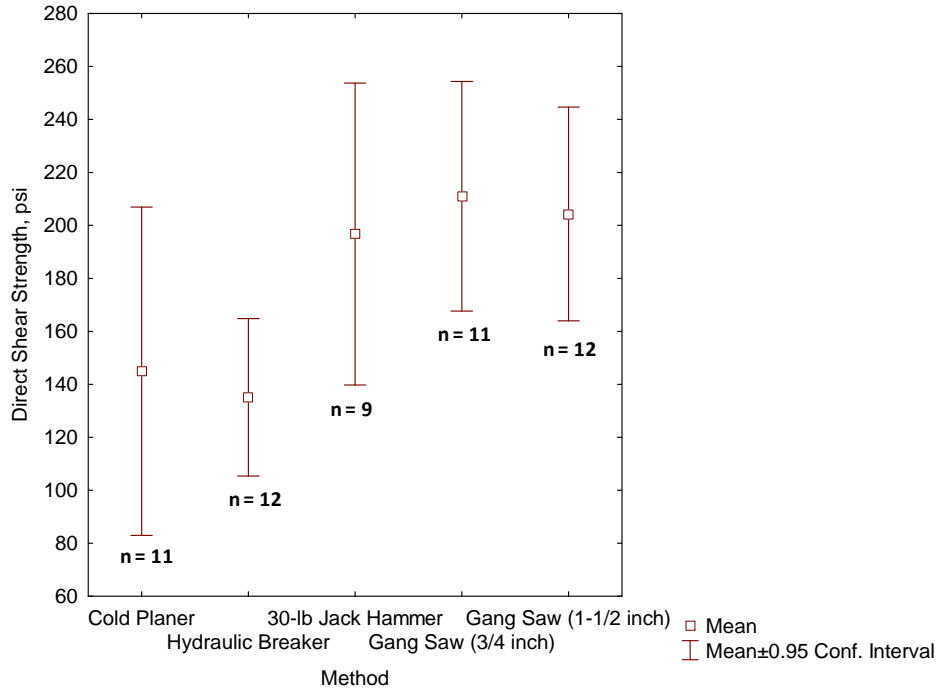
Figure 33. Whisker Plot of Post-Trafficking Direct Shear Data.

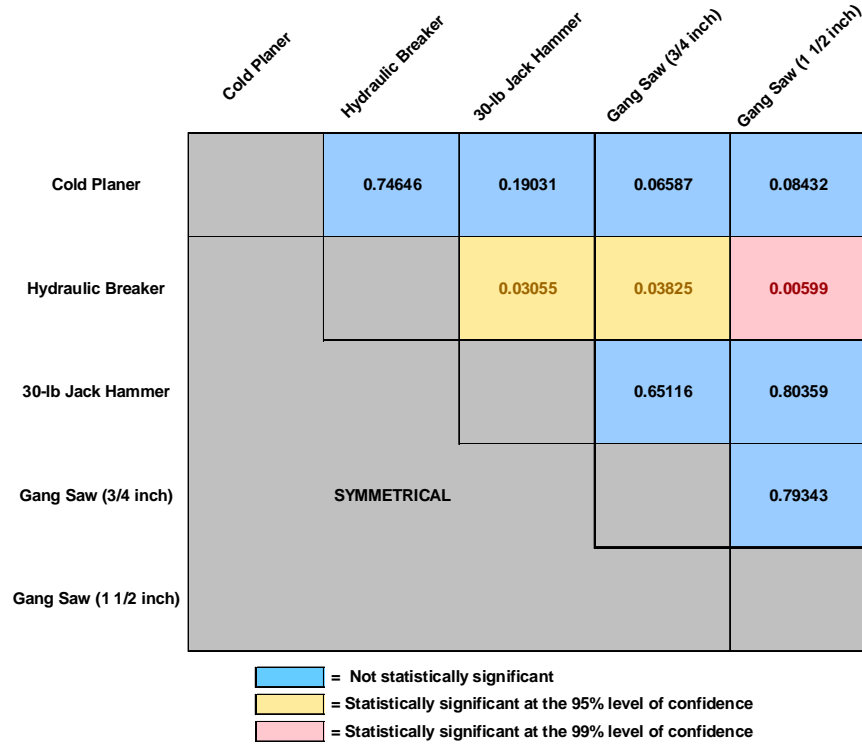
Figure 34. P Value Matrix for Post-Trafficking Direct Shear Experiments.

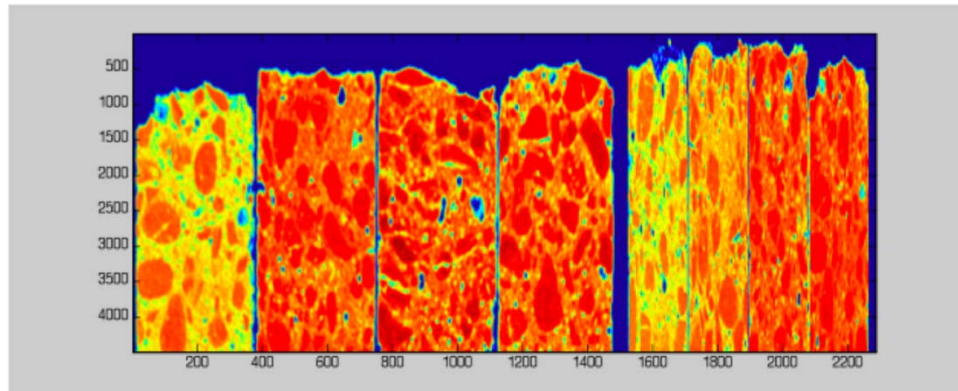
Figure 35. Raw Ultrasonic Reflection Image Data for Two Specimens Sets with One Duplicate Sample for Matching.

Figure 35 shows the two raw data sets collected from the immersion scanning system for the specimens in this study. These data were re-sampled so that both data sets had a y-axis spacing of 0.01 inch (or 100 scan lines per inch). From this figure one can observe a darkening or shift in the image panels from left to right. Figure 36 shows a second graphing made to try to quantify this observation. In Figure 36 each scanned line in the z-direction (vertical) was averaged; thus we are looking at the average change in z as we move across the samples in y. Note that the first and last panels are two different scans of the same panel (or specimen). From this data we can see that the primary difference is an offset between these two datasets. In Figure 37 and Figure 38 relative location and legends are given for each sample in the scanned groups. Note that specimen 070100 (the gang saw at $\frac{3}{4}$ inch spacing) was located in both glued up specimen sets to provide a comparison check between the two. Two different control specimens both labeled 070102 (core from pad) were also included in each scanned group

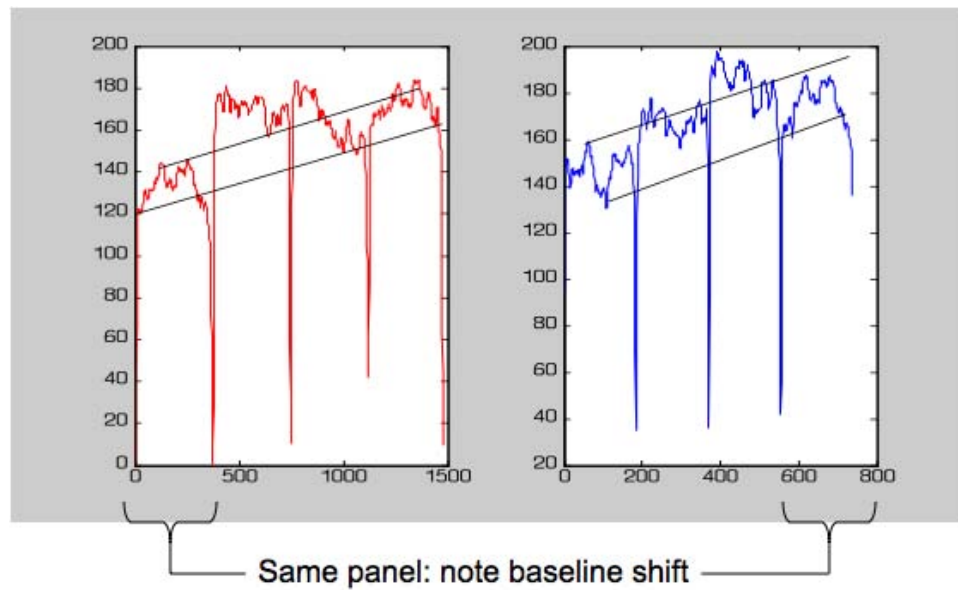
Figure 36. Averaged Data in Z across Two Data Sets.

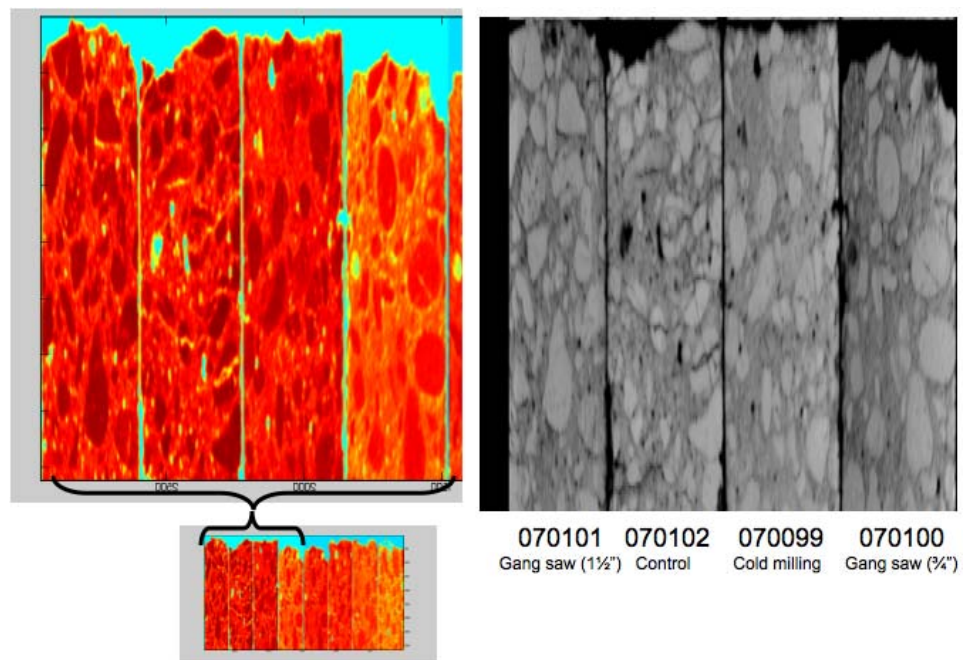
Figure 37. Color and Greyscale Images of First Group of Scanned Specimens.

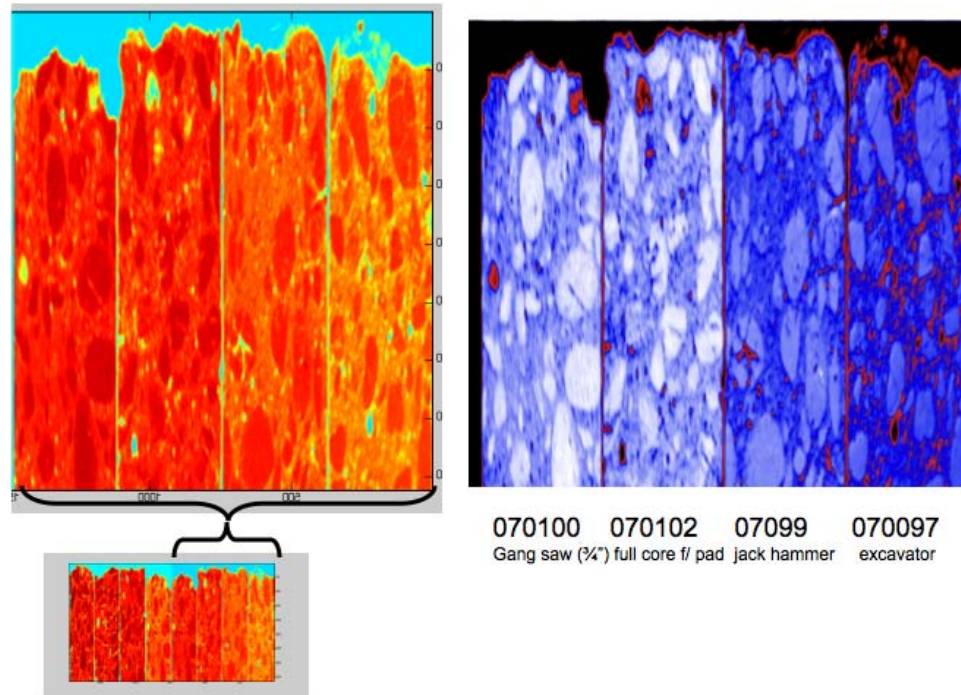
Figure 38. Color and Grayscale Images of the Second Group of Scanned Specimens.

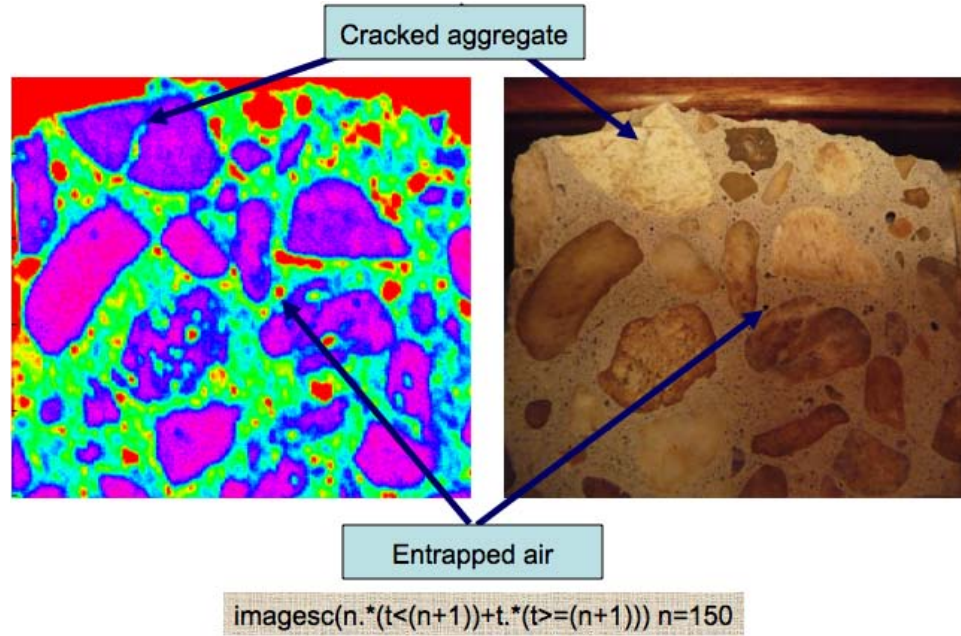
Figure 39. Adjustment of Ultrasonic Color Palate to Enhance Features.

Figure 39 shows an example of detected aggregate cracking and entrapped air. For each specimen the N value (starting palate value) was adjusted so that visual air voids were captured as accurately as possible. In general, specification of the N value picks the starting point of the Matlab HSV color palate. The value of N was determined by trial and error manual visual comparisons such that the color-coded image most accurately depicted the observable larger air voids. The equation used to adjust the palate is shown in Figure 39.

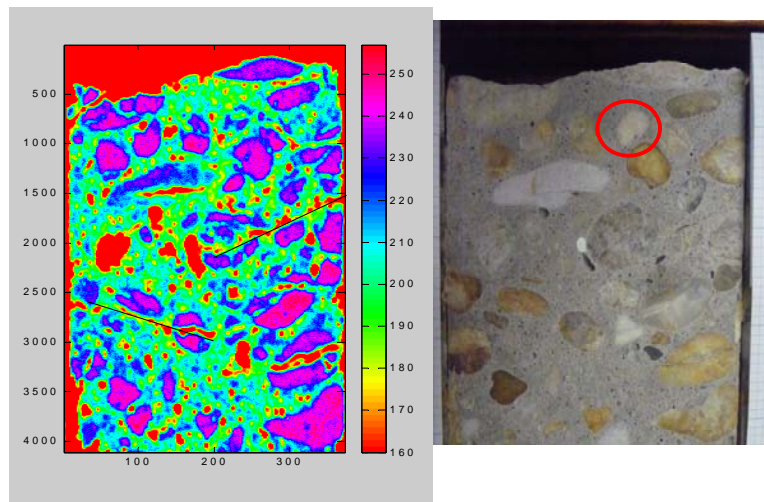
Figure 41. Images of Full Core from Pad.
